Overtopping Modifications to Tygart Dam

Mark P. Zaitsoff, P.E.¹

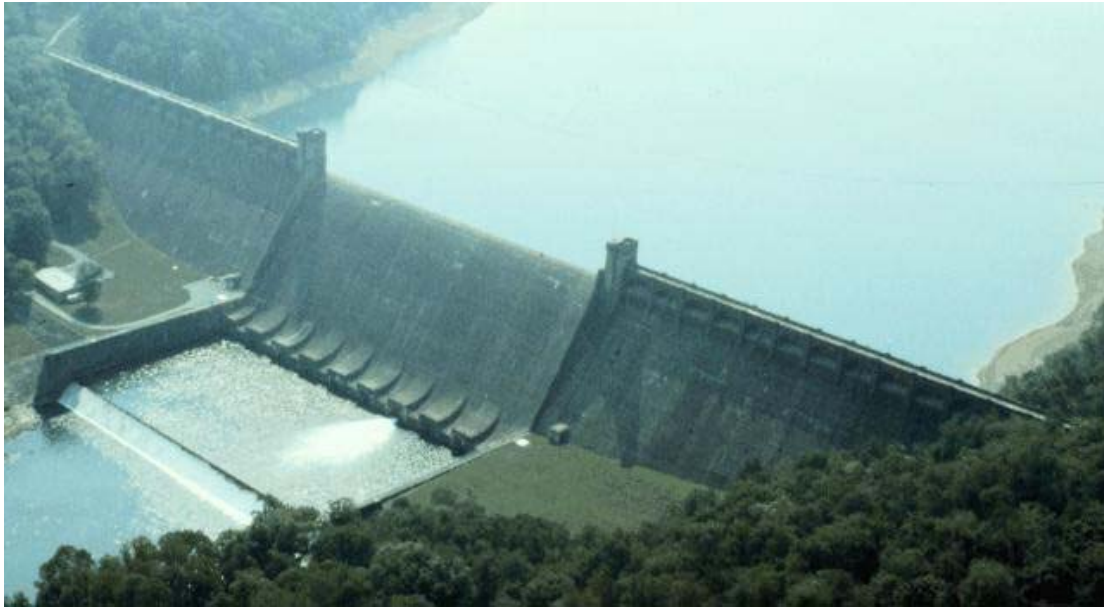
Figure 2. Tygart Dam (before modifications)

Tygart Dam is a concrete gravity type structure with an uncontrolled spillway located approximately in the center of the dam (Figure 2). The total width of this spillway is 489 feet. Abutment sections on each side of the spillway extend 23 feet above the spillway crest to a roadway with four foot high parapet walls. The overall length of the dam is 1921 feet. The crest of the spillway is at elevation 1167 FT NGVD and is 234 feet above the streambed.

Tygart Dam was hydrologically and hydraulically deficient according to current Corps of Engineers standards. The dam, properly designed and built in the mid 1930s, no longer met today's updated and revised dam safety standards.

parapet walls. The current estimate of the PMF is 375,350 CFS, 88% greater than the spillway capacity. The PMF will result in a maximum water surface of about 2.5 feet above the top of the parapet walls; the duration of overtopping will be about 11 hours.

Overtopping flows will impinge on the downstream abutments and toe and scour foundation material from an area critical to the stability of the dam. An overtopping of this magnitude is likely to cause sudden and complete failure of the structure. The failure of Tygart Dam by overtopping would occur as sliding or overturning of one or more monoliths due to undermining and loss of toe support. The failure of one monolith would probably cause adjoining monoliths to fail due to loss of lateral support and undermining by concentrated flow through the breach. Based on documented failures of other dams, a failure of Tygart Dam caused by overtopping probably would be complete, sudden and with little visible sign of distress.

The study evaluated these alternatives and recommended that, with structural modifications, the dam be allowed to overtop. The overtopping alternative was then physically modeled to validate and refine the modifications. The modeling was conducted at the Waterways Experiment Station at a cost of \$515,000. The modeling confirmed that the existing stilling basin would perform adequately and would not need to be extended; this saved about \$18,000,000 from the cost of the project.
